Pumping challenging raw wastewater

Case study Lünen-Gahmen pumping station, Lippeverband (Germany)

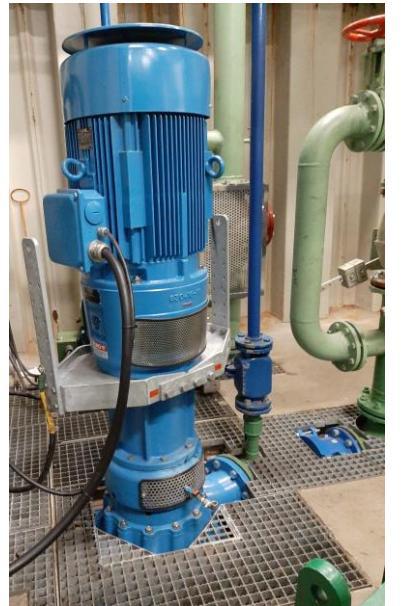
The replacement of the M2 by the T 71-150 V4 LB4B with 150 mm free passage could reduce the operating and repair costs to an absolute minimum from the end of 2012. There were no further blockages (see picture on the left of the M2 pump).
